- 2 different pairs of differential vias: BC2 (left) and BCREf (right)
- They seem exactly the same: going from TOP to the Bottom and connecting signals from the Top to the L3

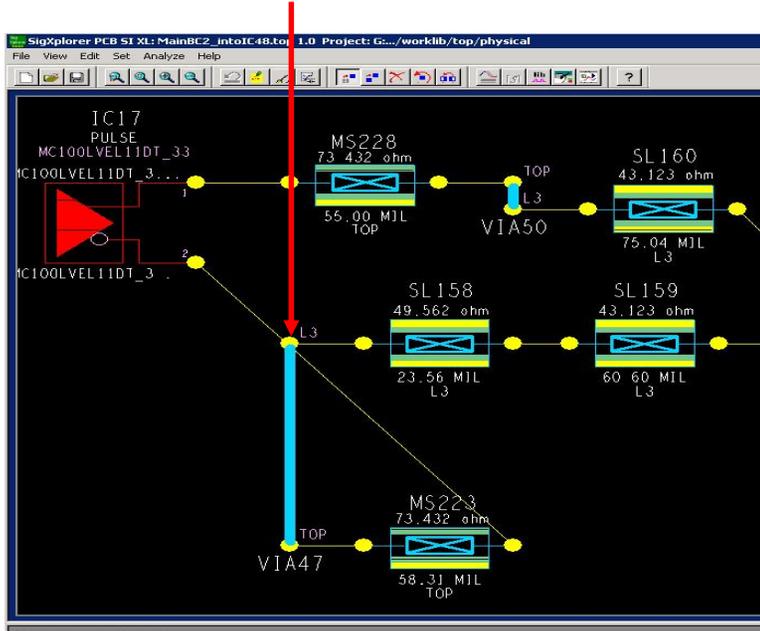
- This is the VIA extracted for BC2

Why the extracted vias are looking different ?!

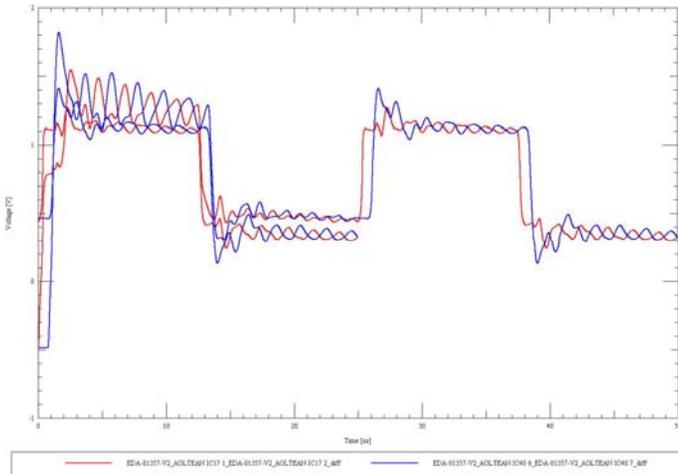
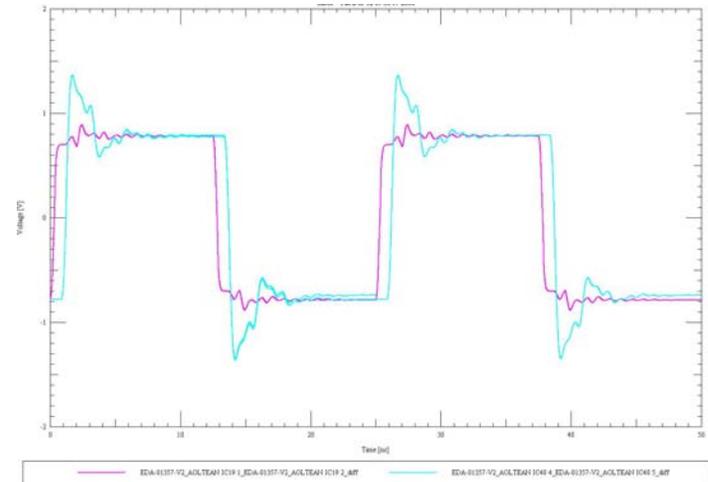
The signals for BC2 are looking as well different (and bad!) compared to BCREF
